LEFT FRONT WHEEL WELL

STEERING SECTION

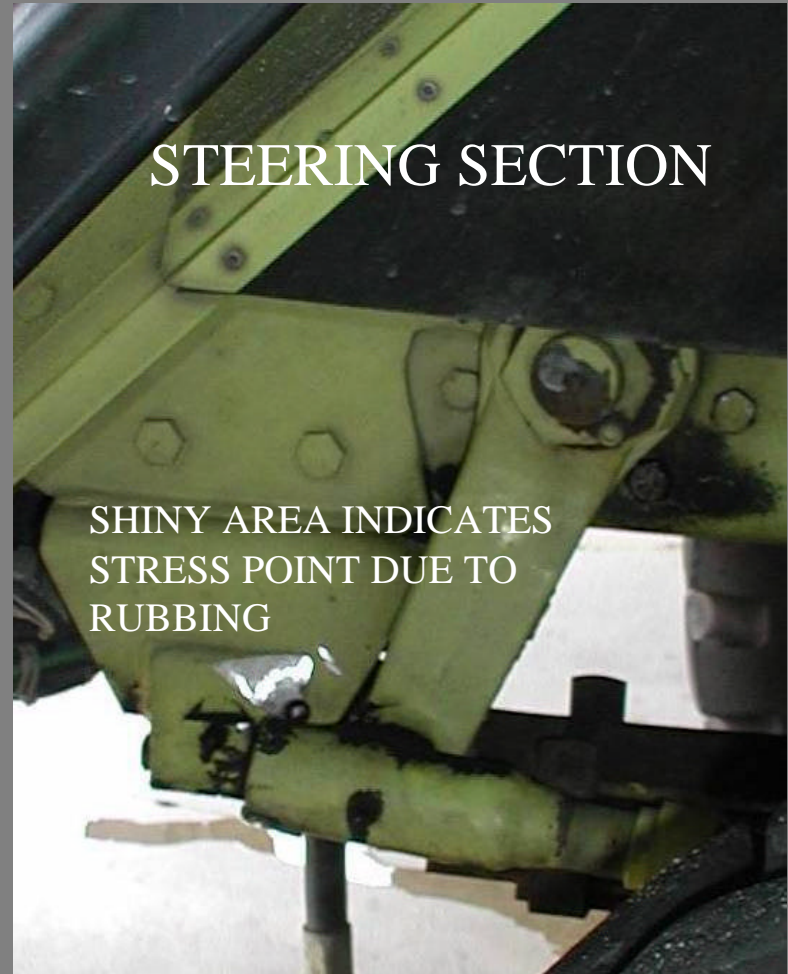
SHINY AREA INDICATES
STRESS POINT DUE TO
RUBBING

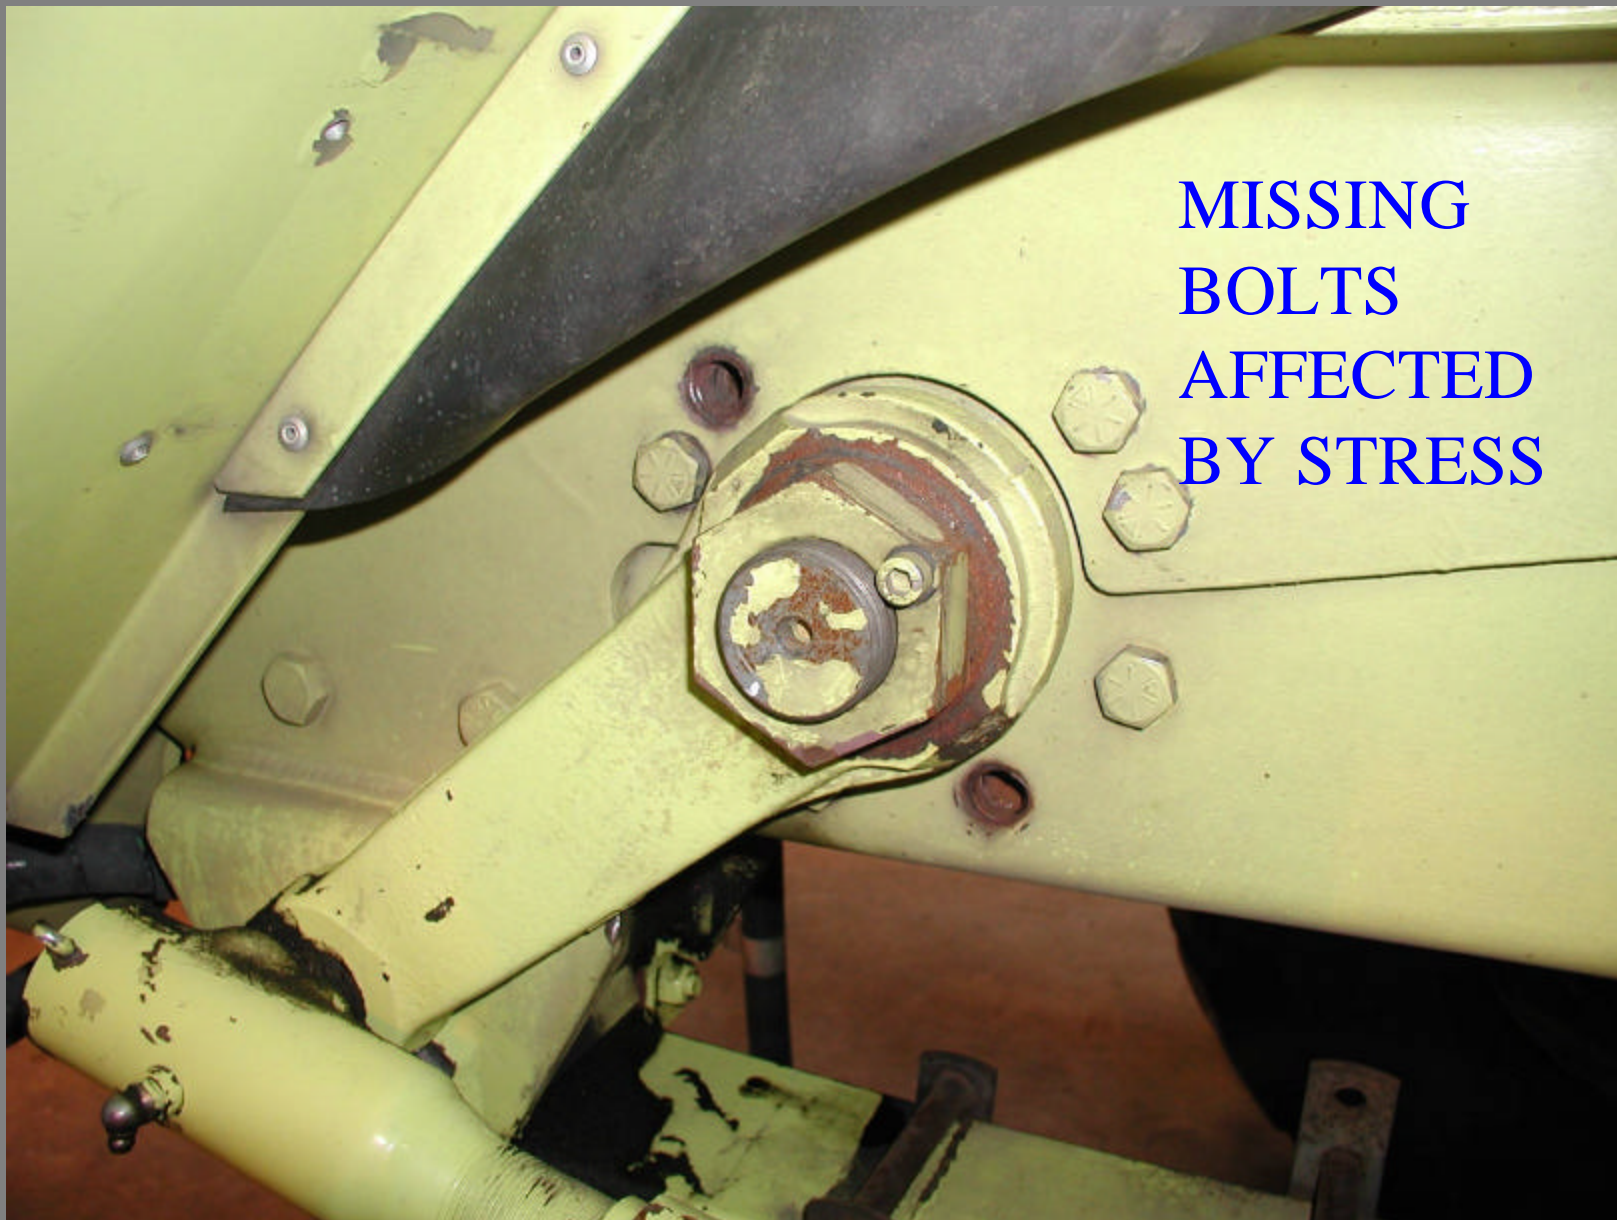
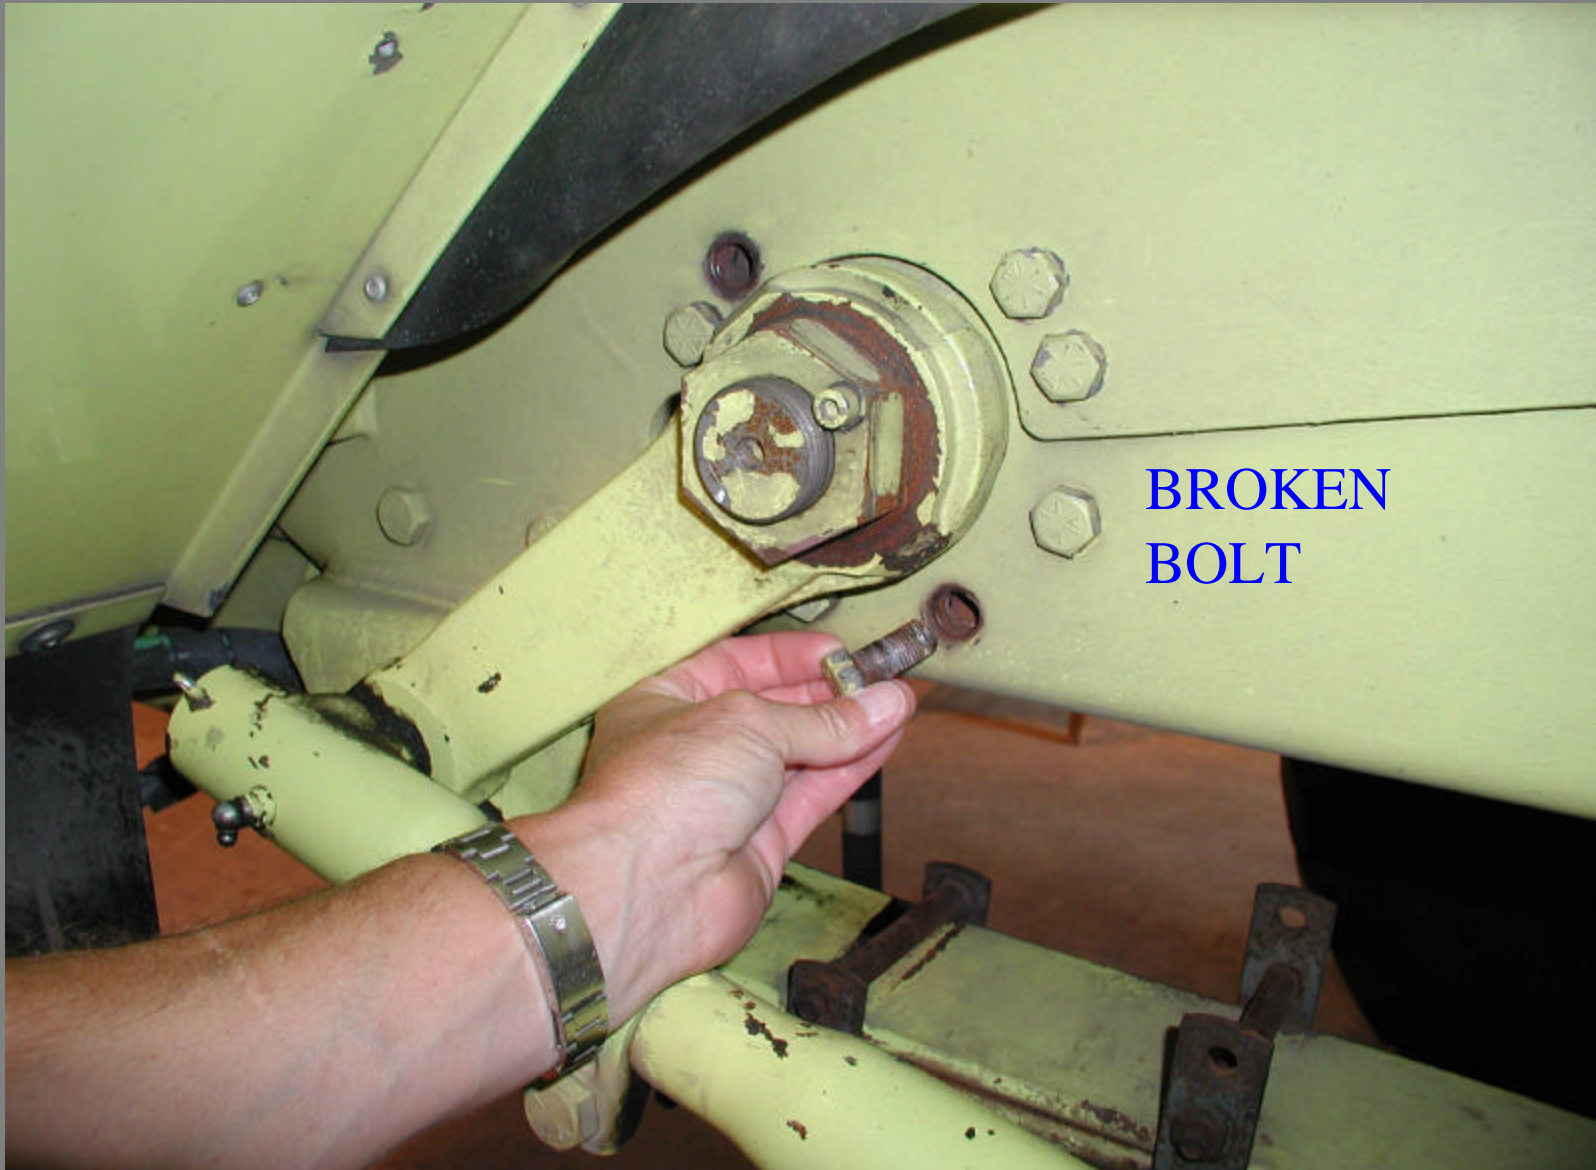
MISSING
BOLTS
AFFECTED
BY STRESS

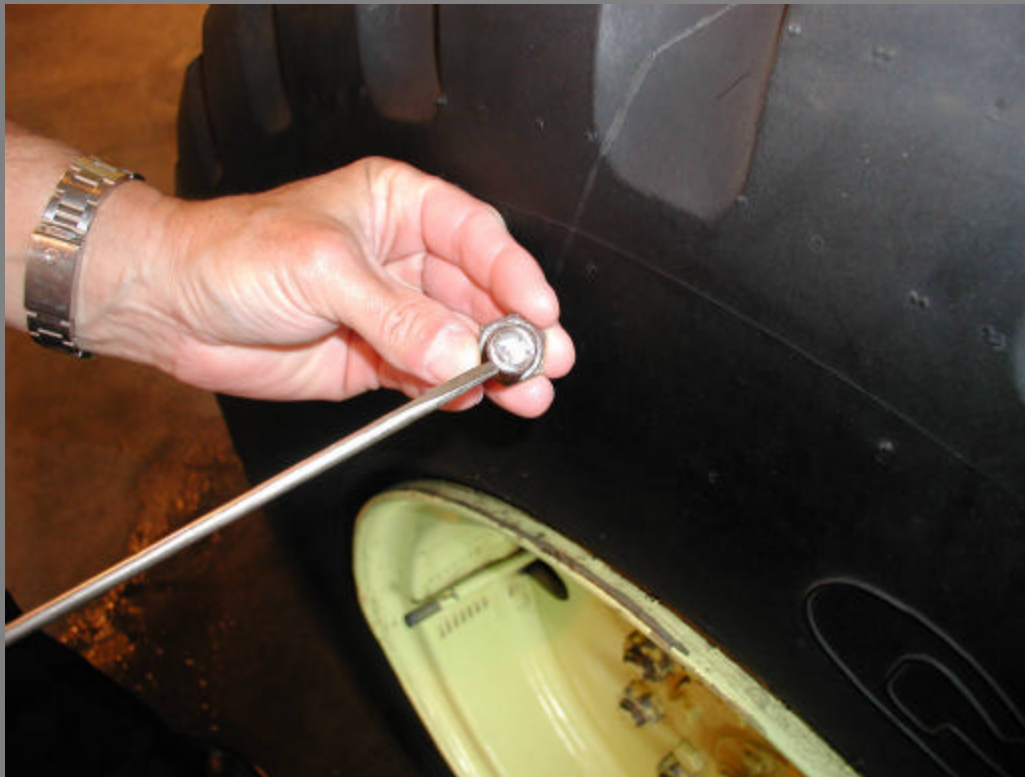
BROKEN
BOLT

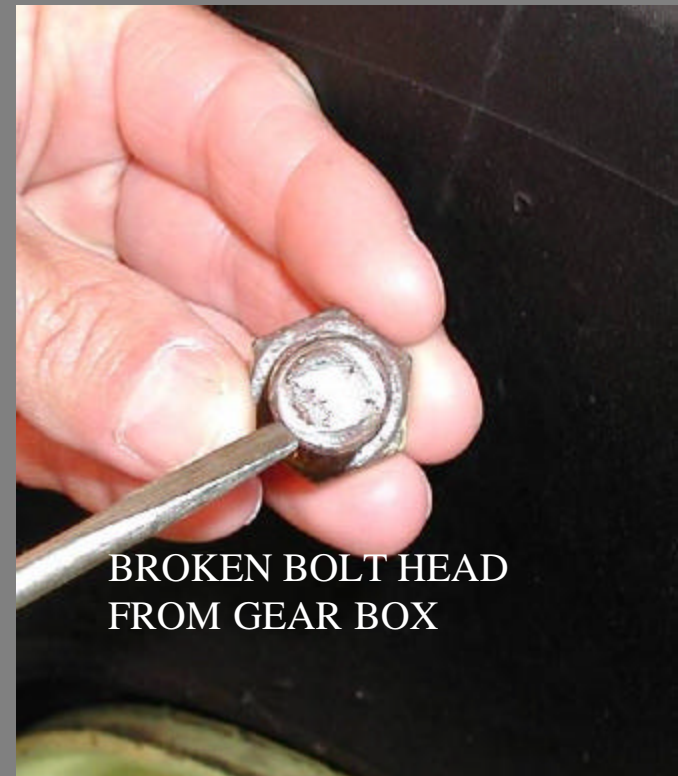
BROKEN BOLT HEAD
FROM GEAR BOX

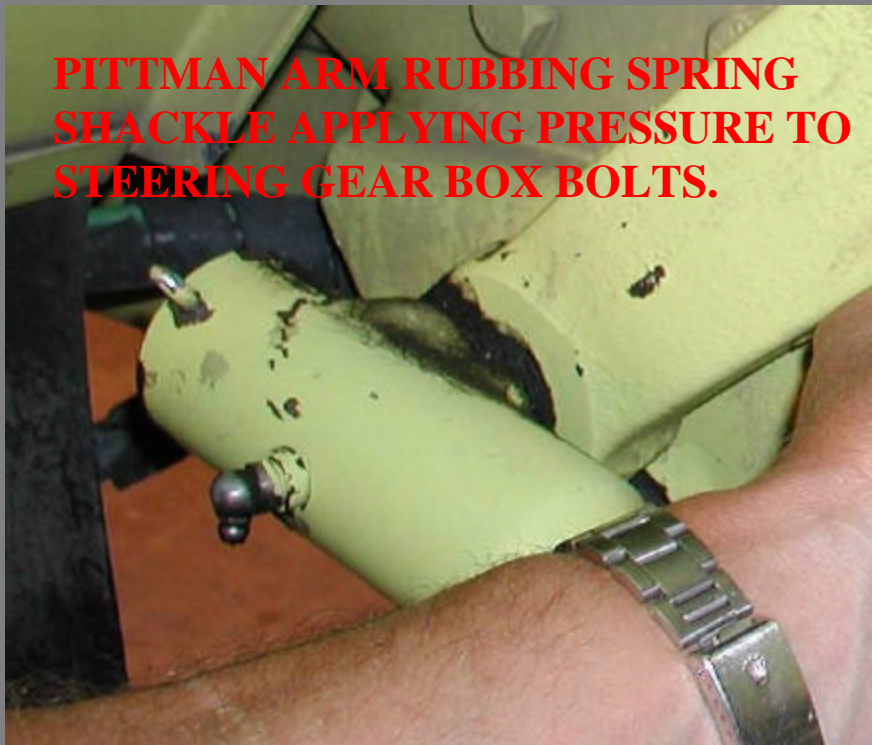
**PITTMAN ARM RUBBING SPRING
SHACKLE APPLYING PRESSURE TO
STEERING GEAR BOX BOLTS.**
